Project:	Cobblestone pavement – grouting and levelling
Location:	Lenningen
Year of construction:	2018
Product:	Rapid Set MORTAR MIX

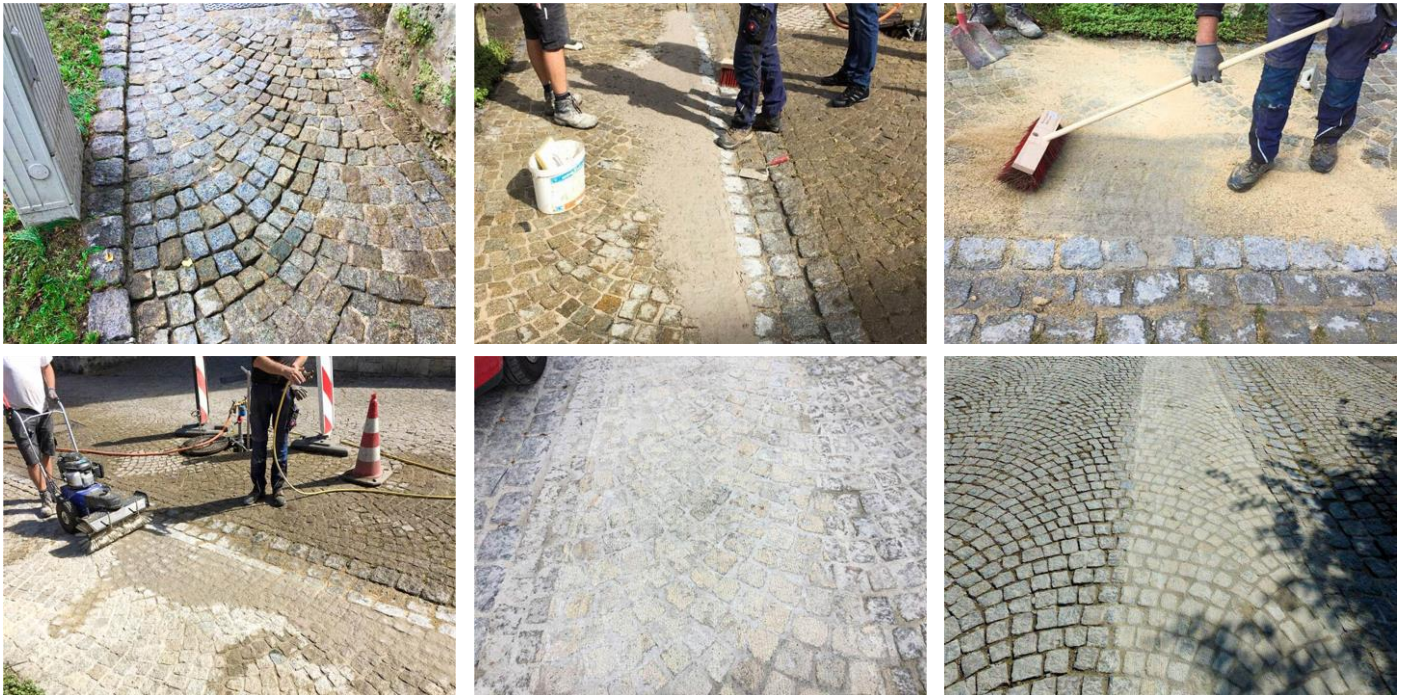
First, the routing of the barrier-free distance through the community was defined. Then the uneven cobblestone surfaces were worked on. The existing joint mortar was removed to a depth of more than 30 mm using a high-pressure cleaner (> 300 bar) and replaced by a new joint filler - the multipurpose KORODUR repair mortar, Rapid Set MORTAR MIX. The surfaces were cleaned and only one day later levelled barrier-free by means of a special, patented milling machine. Conventional grouting does not allow such short procedures. The fast-setting and high-strength Rapid Set Repair mortars, however, are designed for fast working techniques involving only short shut-down times – thus an economic advantage.
